# ANATOMY OF A VALVE FAILURE

Burned exhaust valves have long been a leading cause of cylinder failures and power loss in piston aircraft engines. Modern borescopes allow us to look deep inside cylinders—and this guide will help you interpret what you see through the viewfinder.

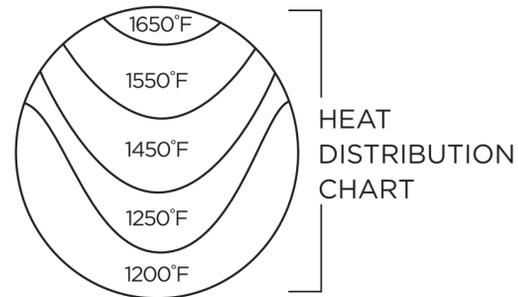
**OVERVIEW:** Valves that fail to seat properly are subject to severe and uneven heating that can cause them to weaken and fail in predictable patterns.

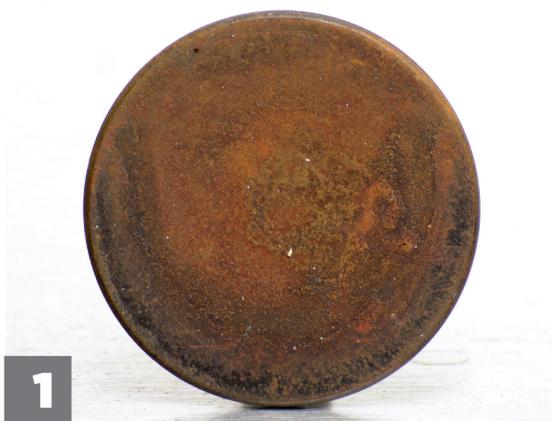
**1** First indication: Circular color pattern is slightly uneven and nonsymmetrical.

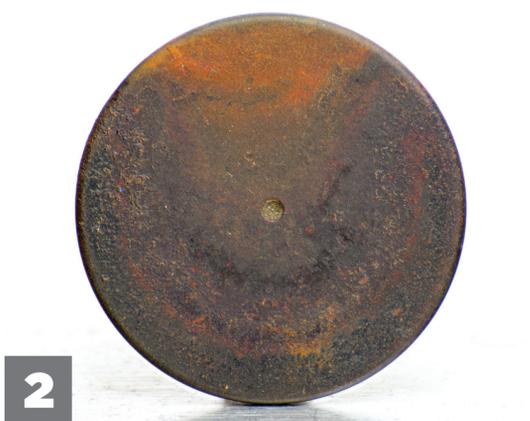
**2** Crescent-shape, discolored burn pattern developing at upper edge.

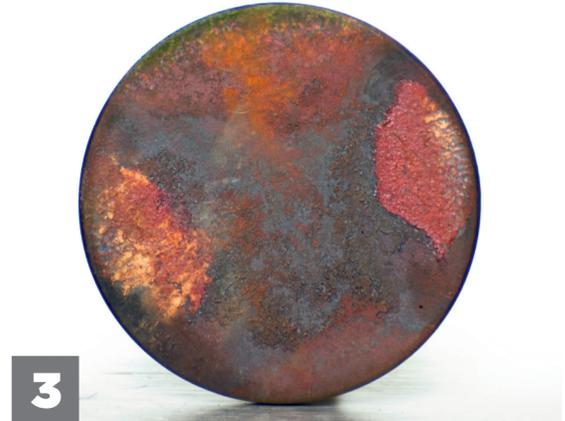
**3** Burn pattern migrates inward.

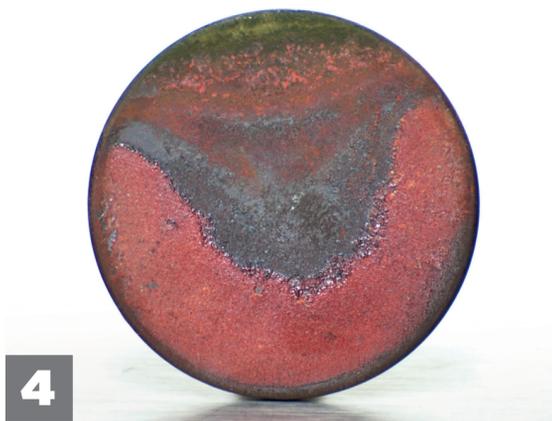
**4** **GREEN MEANS STOP.** The green area at the top shows this **valve should be replaced immediately.** (Note how the uneven burn patterns match the heat distribution chart.)

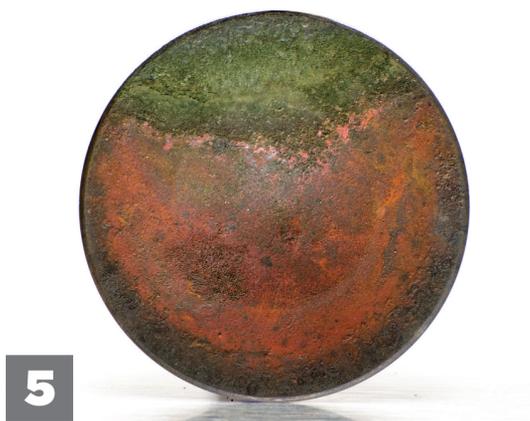
**5** Green crescent progresses toward center with valve cracking and failure a serious danger.

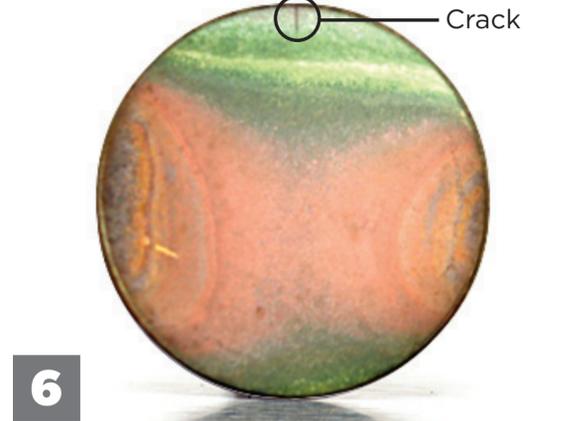
**6** Crack at 12 o'clock shows valve failure is imminent.

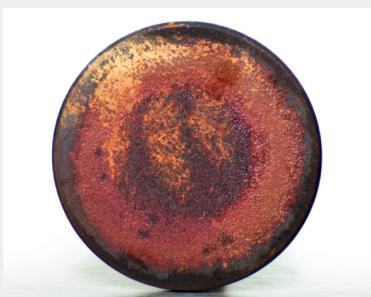
Don't be alarmed by the bright color, or deposits around the edges. The symmetrical pattern shows this valve is just fine.

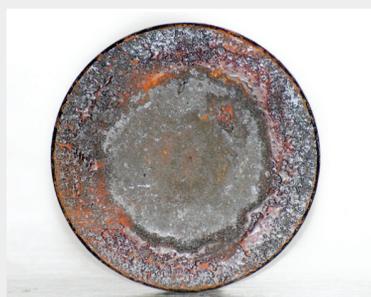
A symmetrical, circular pattern shows a healthy valve. Red and orange deposits are harmless.

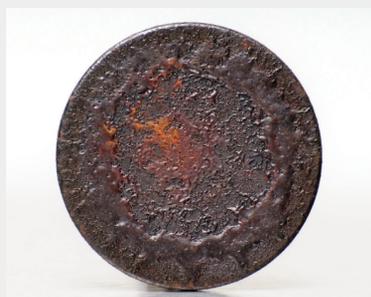
Thick lead deposits from an overly rich mixture give this healthy valve the appearance of an overcooked pizza.
